# DAL-TILE CORPORATION FIRE TEST REPORT

ASTM E108 TESTING ON ROOF ASSEMBLY CONTAINING DAL TILE PERENNIAL ROOF TILE

103469556SAT-001A

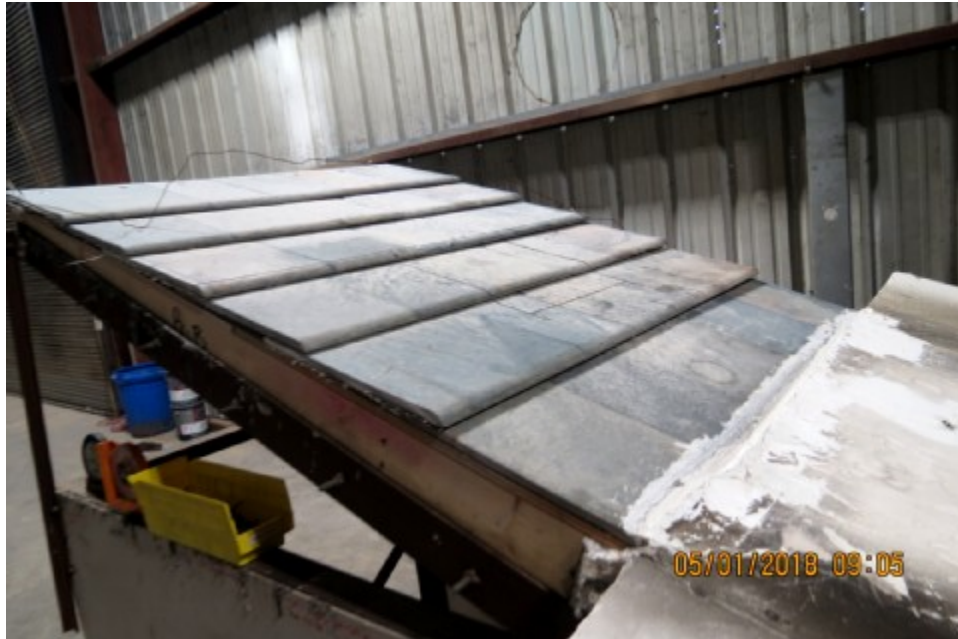
**Photo No. 1  
TEST #1 BEFORE**

**Test Observations Deck: 1**

Test Date	05/01/2018
Ambient Air Temperature	84°F
Brand Type	Class A, 4.2 lbs.
Slope of Test Deck	5:12

BRAND #	TIME (min:sec)	OBSERVATIONS
1	0:00	Ignited brand placed on deck.
	1:22	Cracking visible on tile.
	2:01	Cracking sound was heard.
	2:12	Cracking sound was heard.
	2:43	Cracking sound was heard.
	4:26	Smoke was visible through underside of joint.
	5:39	Cracking sound was heard.
	7:58	Cracking sound was heard..
	9:50	Smoke increasing.
	10:10	Discoloring at the underside of joint.
	13:17	Flame visible between tile and deck (course 3).
	19:13	Cracking sound was heard.
	20:00	Charring area increasing and glowing, visible at joint.
	24:10	Small blue flame at course 3 from plastic on top of deck.
	27:00	No sign of flame.
	37:00	No sign of smoke.
	43:00	No signs of flame or smoke underdeck. All glowing pieces for brand have self-extinguished. Test is terminated.

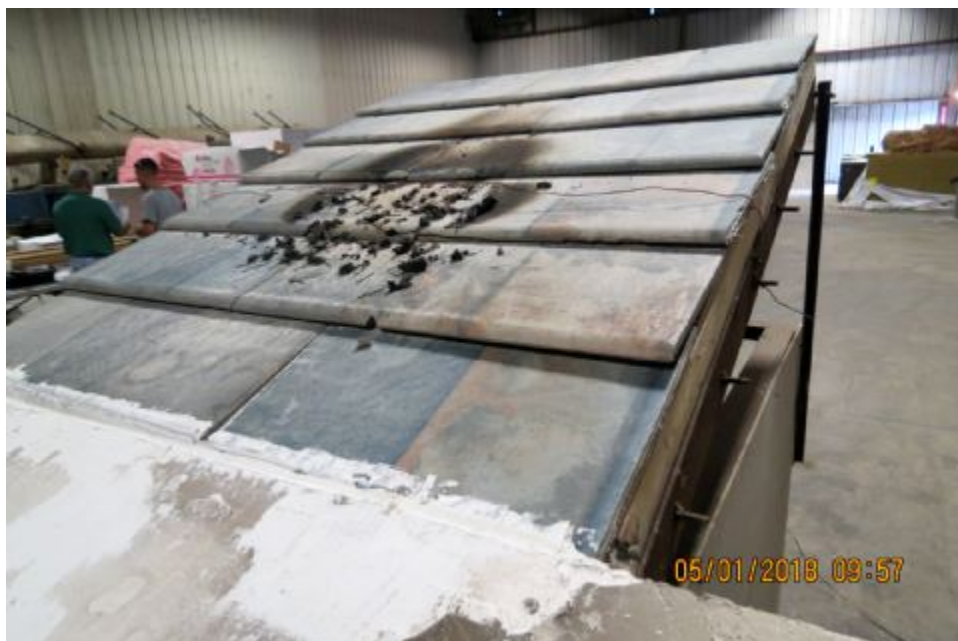
**Photo No. 2  
TEST #1 AFTER**

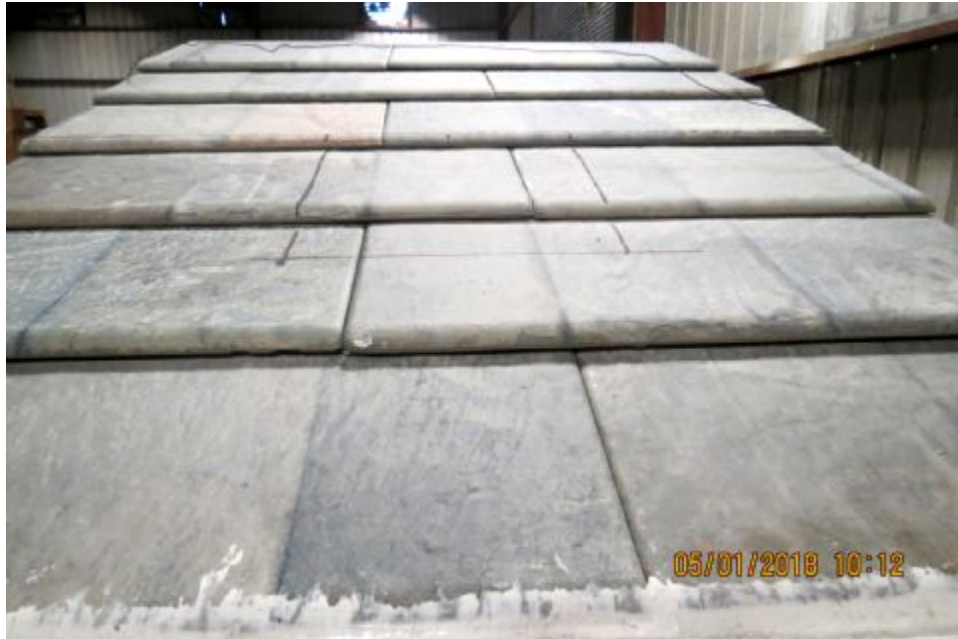
**Photo No. 3**  
**TEST #2 BEFORE**

**Test Observations Deck: 2**

Test Date	05/01/2018
Ambient Air Temperature	73°F
Brand Type	Class A, 4.2 lbs.
Slope of Test Deck	5:12

BRAND #	TIME (min:sec)	OBSERVATIONS
1	0:00	Ignited brand placed on deck.
	0:48	Cracking sound was heard.
	1:21	Cracking sound was heard.
	1:27	Cracking sound was heard.
	1:48	Cracking sound was heard.
	2:42	Cracking sound was heard.
	4:58	Cracking sound was heard.
	5:51	Smoke was visible through underside of joint.
	8:41	Cracking sound was heard.
	9:30	Smoke increasing.
	10:14	Discoloring at the underside of joint.
	30:00	Flame and glowing from brand have self-extinguished.
	33:00	Light smoke still visible.
	40:00	No signs of flame or smoke underdeck. All glowing pieces for brand have self-extinguished. Test is terminated.

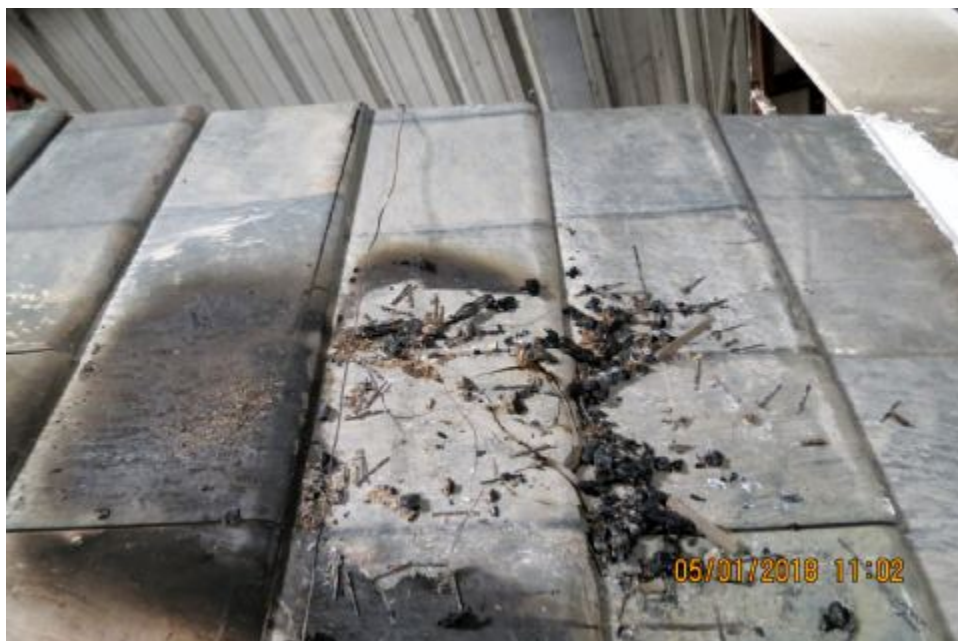
**Photo No. 4**  
**TEST #2 AFTER**

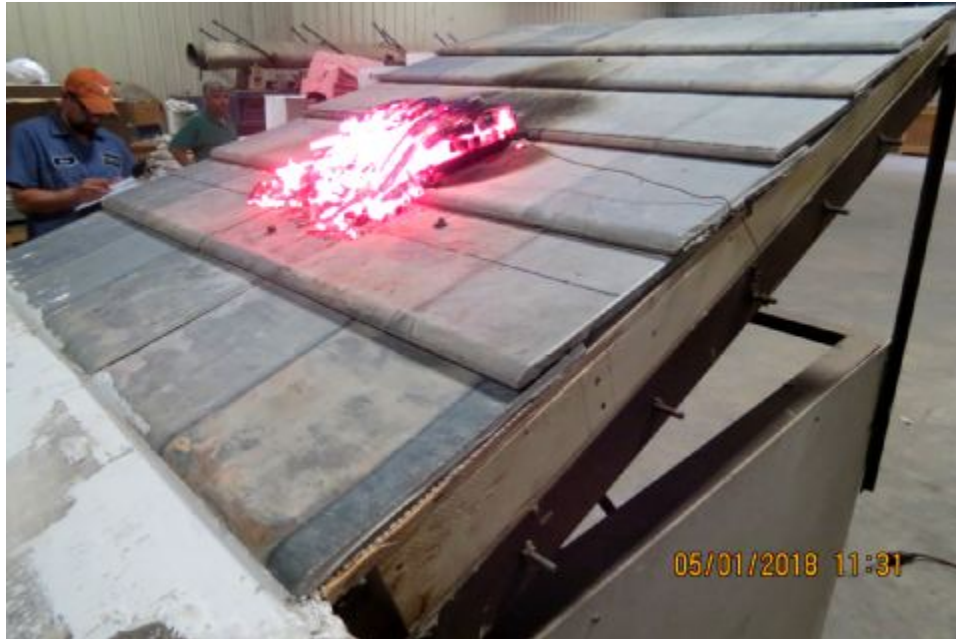
**Photo No. 5**  
**TEST #3 DURING**

**Test Observations Deck: 3**

Test Date	05/01/2018
Ambient Air Temperature	75°F
Brand Type	Class A, 4.2 lbs.
Slope of Test Deck	5:12

BRAND #	TIME (min:sec)	OBSERVATIONS
1	0:00	Ignited brand placed on deck.
	1:03	Cracking sound was heard.
	1:37	Cracking sound was heard.
	2:23	Cracking sound was heard.
	2:31	Cracking sound was heard.
	2:58	Cracking sound was heard.
	3:46	Smoke was visible between the tile and deck, topside.
	5:23	Smoke was visible through underside of joint.
	5:58	Cracking sound was heard.
	7:35	Cracking sound was heard.
	10:03	Smoke increasing at joint.
	11:48	Discoloring at the underside of joint.
	18:36	Light smoke still visible.
	23:51	Flame and glowing from brand have self-extinguished.
	40:44	No signs of flame or smoke underdeck. All glowing pieces for brand have self-extinguished. Test is terminated.

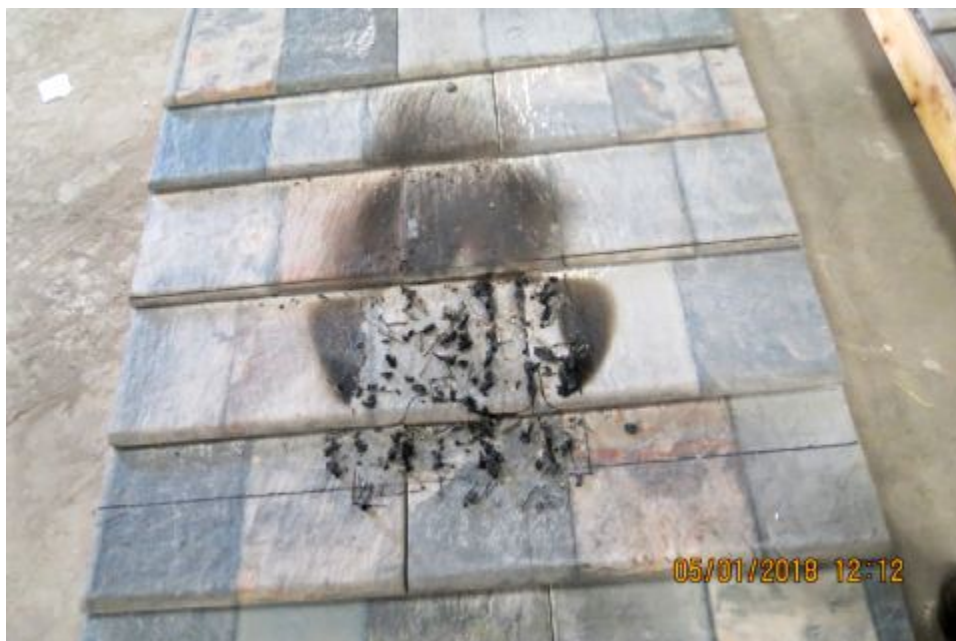
**Photo No. 6**  
**TEST #3 AFTER**

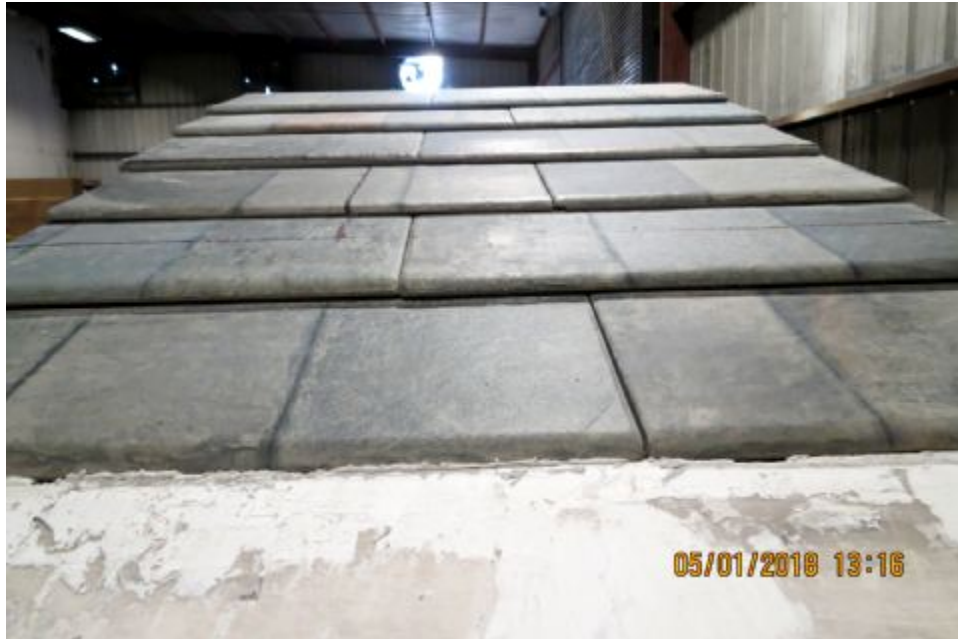
**Photo No. 7**  
**TEST #4 BEFORE**

**Test Observations Deck: 4**

Test Date	05/01/2018
Ambient Air Temperature	81°F
Brand Type	Class A, 4.2 lbs.
Slope of Test Deck	5:12

BRAND #	TIME (min:sec)	OBSERVATIONS
1	0:00	Ignited brand placed on deck.
	0:25	Cracking sound was heard.
	0:50	Cracking sound was heard.
	1:38	Cracking sound was heard.
	1:46	Smoke was visible between the tile and deck, topside.
	3:02	Cracking sound was heard.
	4:39	Cracking sound was heard.
	4:53	Smoke was visible through underside of joint.
	6:12	Cracking sound was heard.
	10:19	Discoloring at the underside of joint.
	10:25	Cracking sound was heard.
	21:57	Smoke decreasing at joint.
	23:03	Flame and glowing from brand have self-extinguished.
	25:34	Smoke and glowing was visible though underside of joint.
	36:22	No signs of flame or smoke underdeck. All glowing pieces for brand have self-extinguished. Test is terminated.

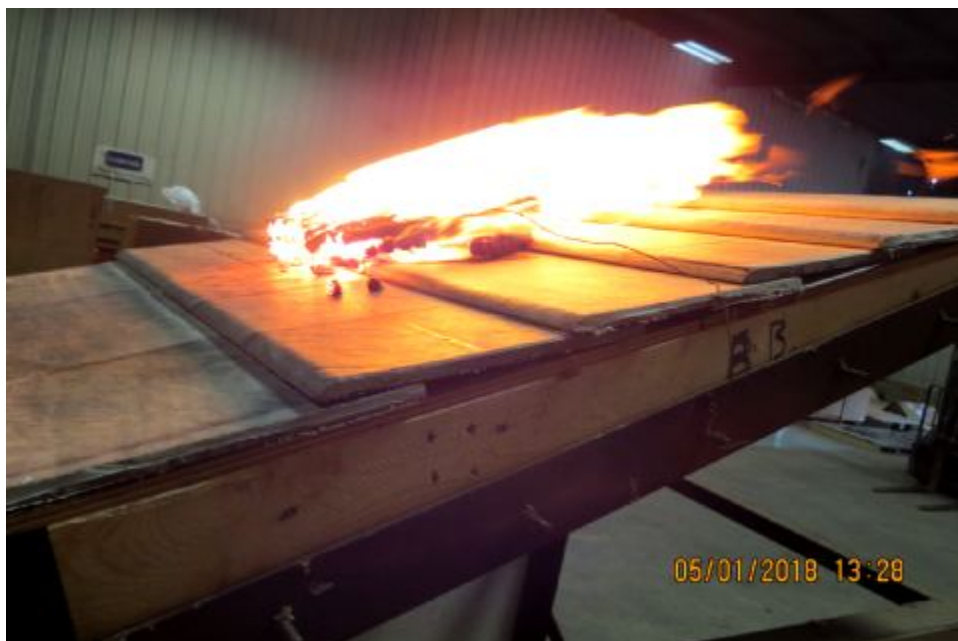
**Photo No. 8**  
**TEST #4 DURING**

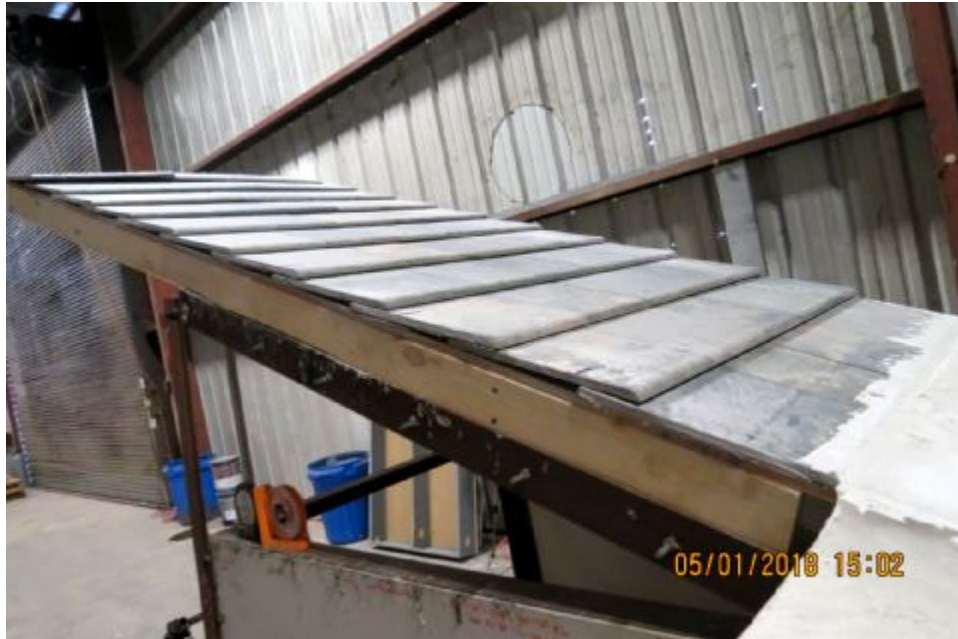
**Photo No. 9**  
**TEST #5 BEFORE (representative of Test 6)**

**Test Observations Deck: 5**

Test Date	05/01/2018
Ambient Air Temperature	84°F
Slope of Test Deck	5:12

TIME (min:sec)	DISTANCE (feet-inches)	OBSERVATIONS/COMMENTS
0:00		Burner ignited.
4:14		Cracking sound was heard.
10:00		Gas burner is turned off. No flame spread observed. Test is terminated.

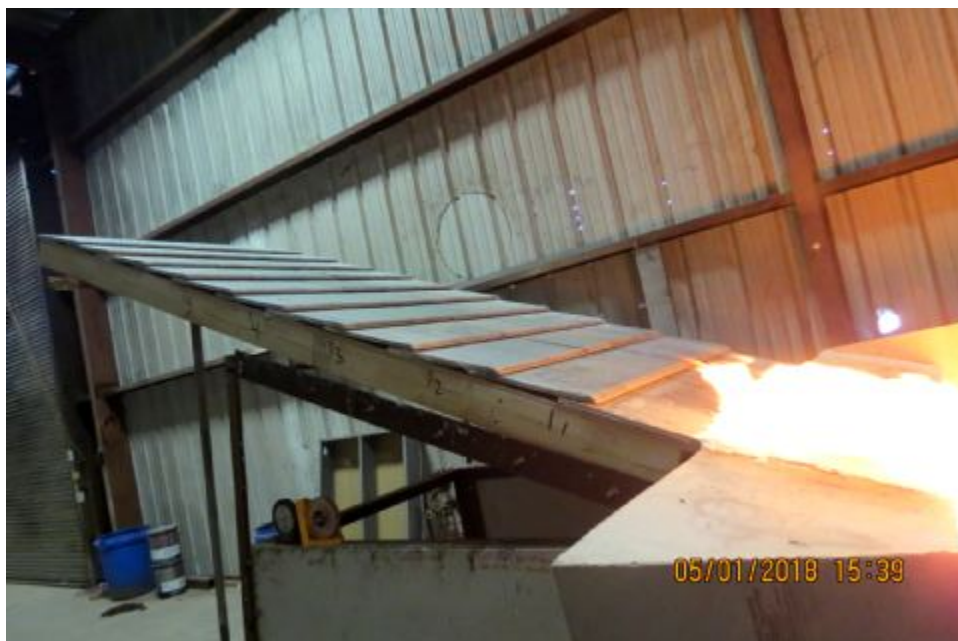
**Photo No. 10**  
**TEST #5 DURING (representative of Test 6)**

TIME (min:sec)	DISTANCE (feet-inches)	OBSERVATIONS/COMMENTS
0:00		Burner ignited.
6:41		Cracking sound was heard.
10:00		Gas burner is turned off. No flame spread observed. Test is terminated.

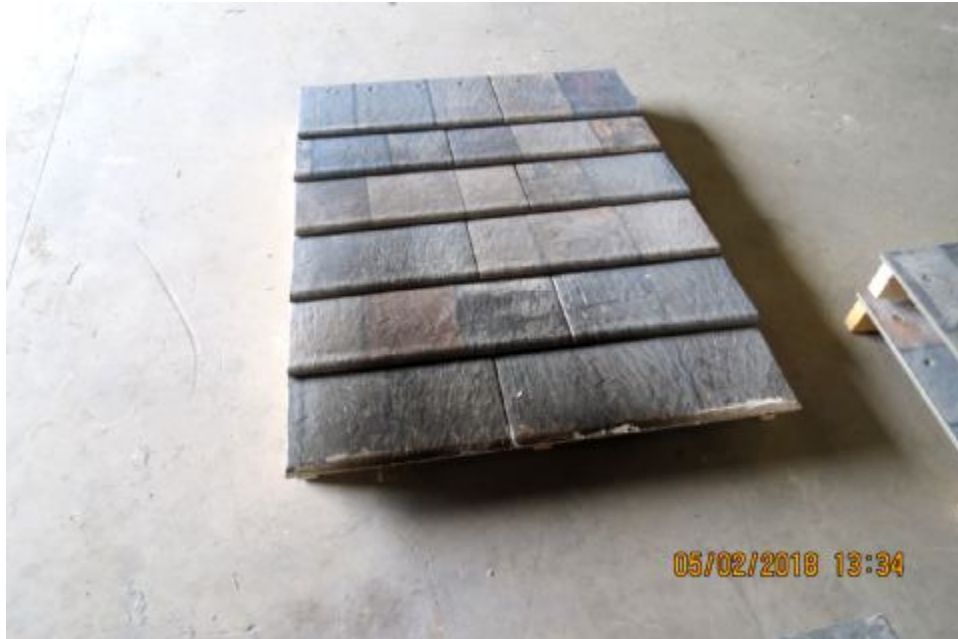
**Photo No. 11  
TEST #7 AFTER**

**Test Observations Deck: 7**

Test Date	05/02/2018
Ambient Air Temperature	81°F
Slope of Test Deck	5:12

CYCLE		TIME TO:		OBSERVATIONS/COMMENTS
NO.	MIN.	IGNITION (min : sec)	FLAME OUT (min : sec)	(Include Off Cycles)
1	Start	None	None	
2	4:00	None	None	
3	8:00	None	None	
4	12:00	None	None	
5	16:00	None	None	
6	20:00	None	None	
7	24:00:00	None	None	
8	28:00:00	None	None	
9	32:00:00	None	None	
10	36:00:00	None	None	
11	40:00:00	None	None	
12	44:00:00	None	None	
13	48:00:00	None	None	
14	52:00:00	None	None	
15	56:00:00	None	None	58:00 Burner off. 60:00 test is terminated.

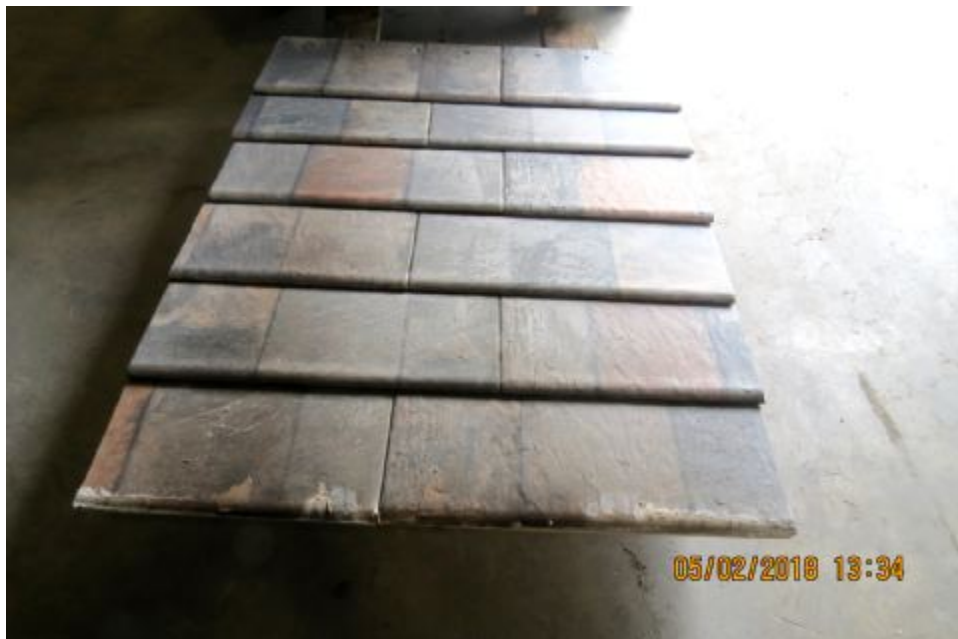
**Photo No. 12  
TEST #8 AFTER**

**Test Observations Deck: 8**

Test Date	05/02/2018
Ambient Air Temperature	72°F
Slope of Test Deck	5:12

CYCLE		TIME TO:		OBSERVATIONS/COMMENTS
NO.	MIN.	IGNITION (min : sec)	FLAME OUT (min : sec)	(Include Off Cycles)
1	Start	None	None	
2	4:00	None	None	
3	8:00	None	None	
4	12:00	None	None	
5	16:00	None	None	
6	20:00	None	None	
7	24:00:00	None	None	
8	28:00:00	None	None	
9	32:00:00	None	None	
10	36:00:00	None	None	
11	40:00:00	None	None	
12	44:00:00	None	None	
13	48:00:00	None	None	
14	52:00:00	None	None	
15	56:00:00	None	None	58:00 Burner off. 60:00 test is terminated.
